Overview of the Accident

On September 12, 2004 at approximately 1345 hours seven members of California Department of Forestry and Fire Protection (CDF) Columbia Helitack (Copter 404) crew had to take emergency action when a sudden wind shift and fire flareup overran their position. Three Firefighters suffered minor injuries and Firefighter Eva Schicke was entrapped and killed.

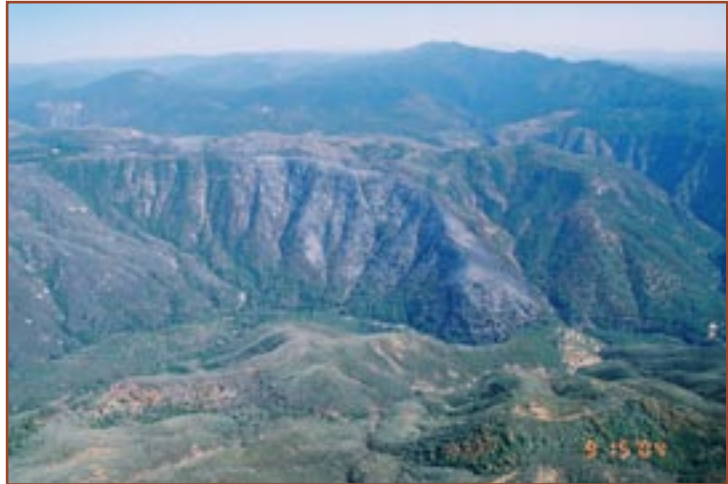
*Tuolumne River Canyon looking South.
Fire and accident site is in center of photo.*
